## **REAL TIME MONITORING OF SUBSIDENCE OVER AN INACTIVE MINE IN VIRGINIA USING TDR**

Kevin M. O'Connor, GeoTDR, Inc, 720 Greencrest Drive, Westerville, OH 43081  
Joseph Crawford, United States Gypsum Company, Chicago, IL 60606-4678  
Kelvin Price, United States Gypsum Company, Saltville, VA 24370  
Roger Sharpe, United States Gypsum Company, Chicago, IL 60606-4678

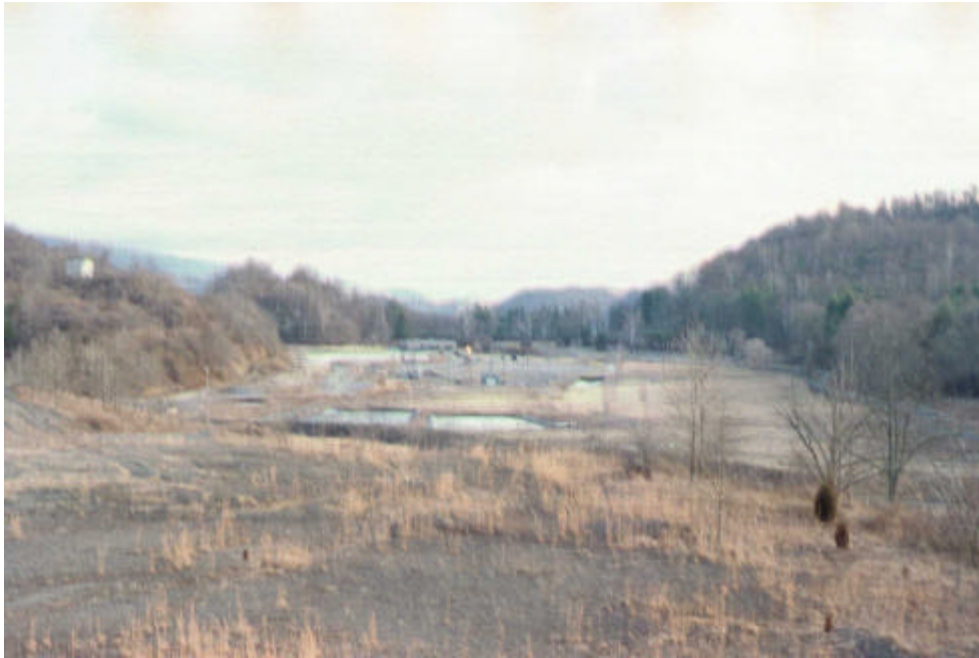
**Figure 1 View looking northeast over the former board plant area. SR91 is at the base of the hill on the right side.**

After cessation of underground mining at Plasterco, the wallboard plant continued production with gypsum supplied from another mine until 1999. The plant was dismantled in 2000. The main plant building and support facilities site covered an area of 100 acres that remains extensively undermined (Figure 1). State Route 91 and County Road 745 are located on the southeast margin of the site and are undermined or near mapped underground workings (to the right in Figure 1). These highways are strategically important as transportation arteries in this area for automobiles, trucks, and school buses. Consequently, keeping these roads open is a critical issue.

The present location of the road is adjacent to and overlies old mine workings, including drifts and stopes. Mine workings as shallow as 15 m (50 ft) below the surface in at least one location (Figure 3). The relocation will involve construction of a new portion of highway several hundred meters east of its present location (Figure 4). In addition, the new alignment is situated at a higher elevation on a massive, rigid beam of limestone that is an upthrown fault block above the detachment surface of the Saltville Thrust Fault (Figure 3). This, in effect, places the road along structurally strong ground that is also vertically separated from the weaker Maccrady mudstones. An extensive coring and laboratory test program was conducted for geotechnical evaluation prior to final alignment selection. Relocation of the highway alignment will require a rock cut about 60 m (200 ft) high. This involves blasting and removal of about 1.0 million m<sup>3</sup> of limestone and/or dolomite. The excavated rock is being hauled across the mine workings and placed as rock fill over the former wallboard plant site (Figures 1 and 4).

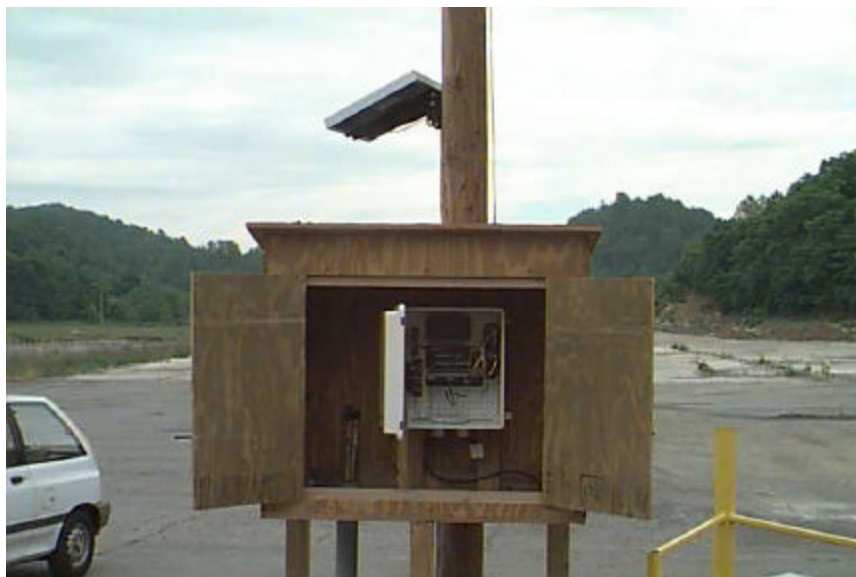
**Figure 6** Data acquisition system. The solar panel trickle-charges the battery. The phone modem is hard-wired to a phone line.

The site is divided into sectors and each cable within a sector extends to a data acquisition system (DAS) for that sector. Each cable is connected to a coaxial multiplexer installed within an enclosure such as the one shown in Figure 6. The multiplexer and TDR cable tester are controlled by a datalogger. The datalogger is also attached to a storage module and modem so each DAS is accessible remotely via phone connection.
